Concrete Bin Failures and Why
Prepared for: GEAPS Exchange 2016

Arthur D. Moeller, PE
Moeller Engineering, LLC

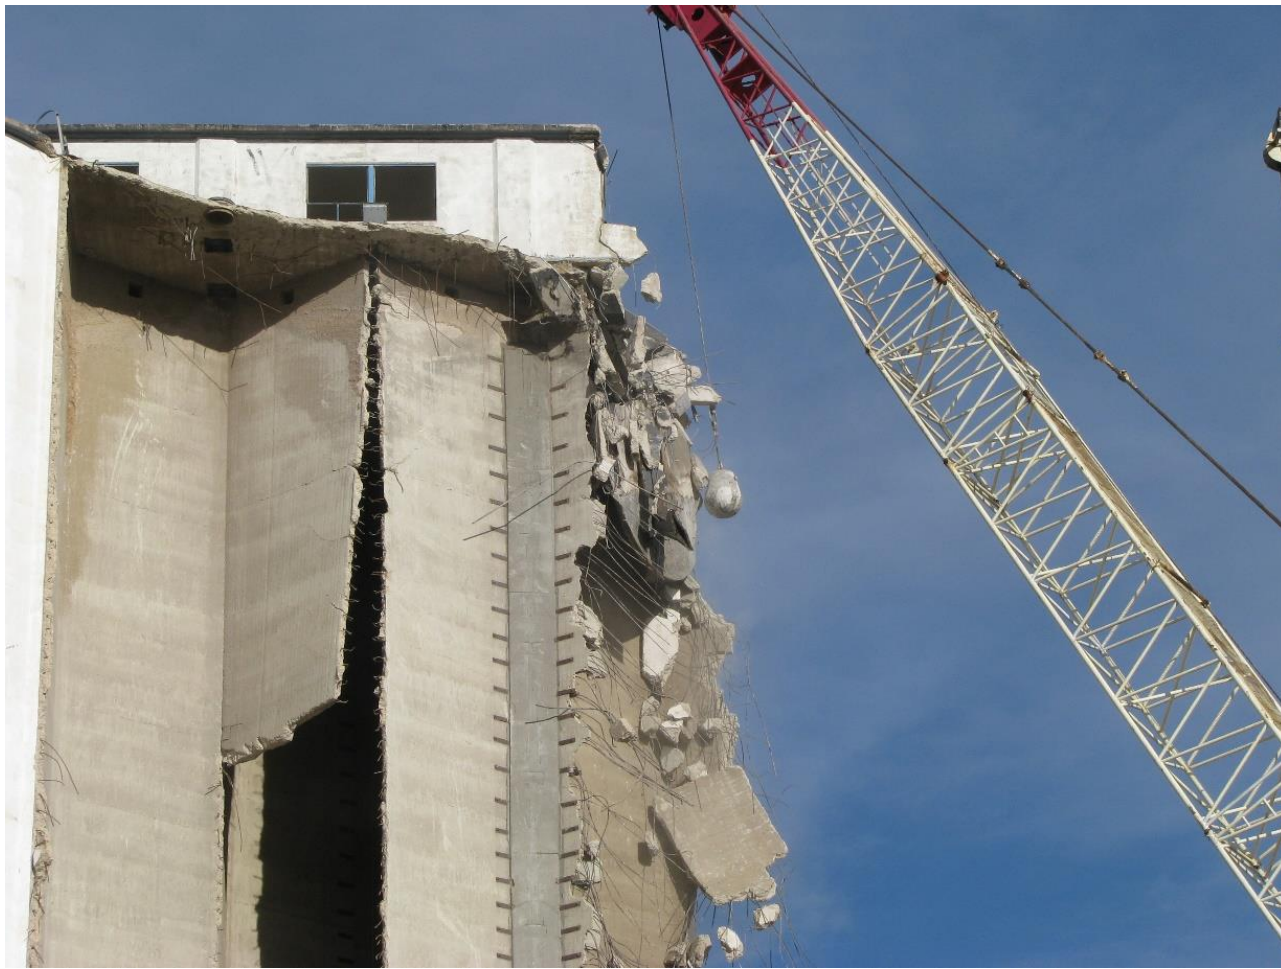
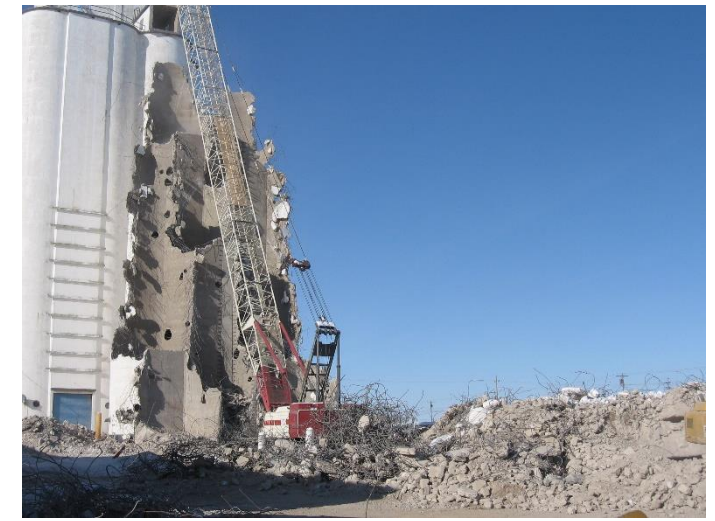
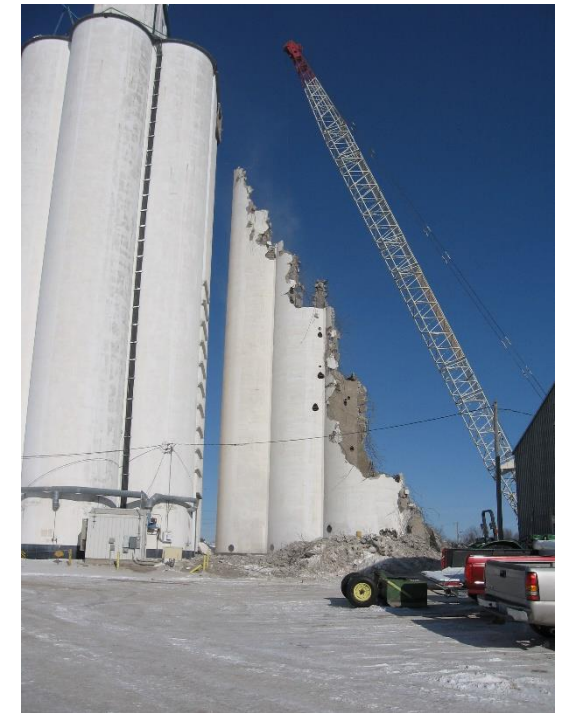
RUSSELL, KS, JUNE 25, 2010
STRUCTURAL FAILURE, COLLAPSE
constructed mid 1950's

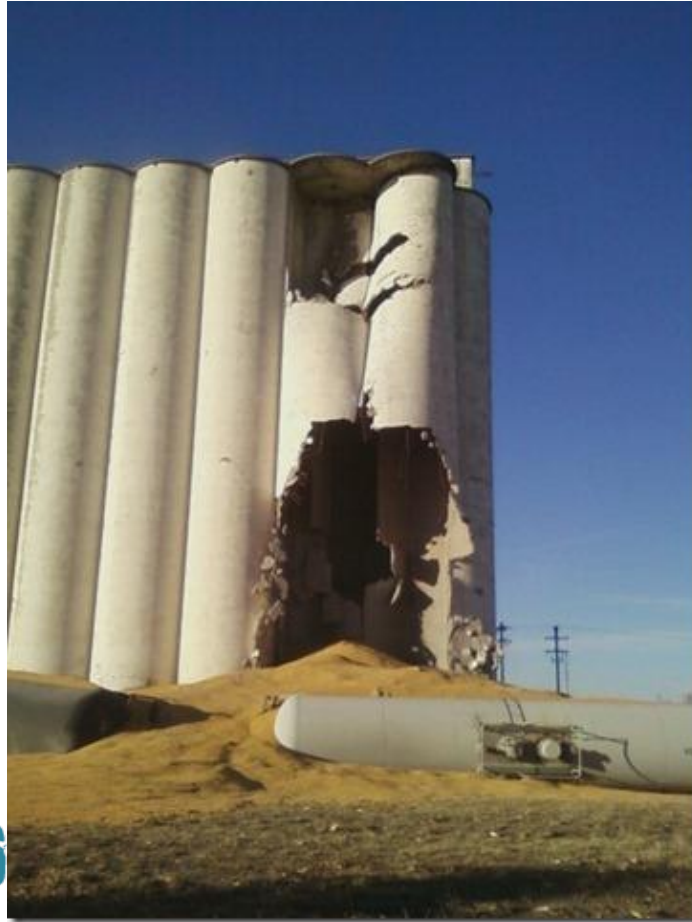
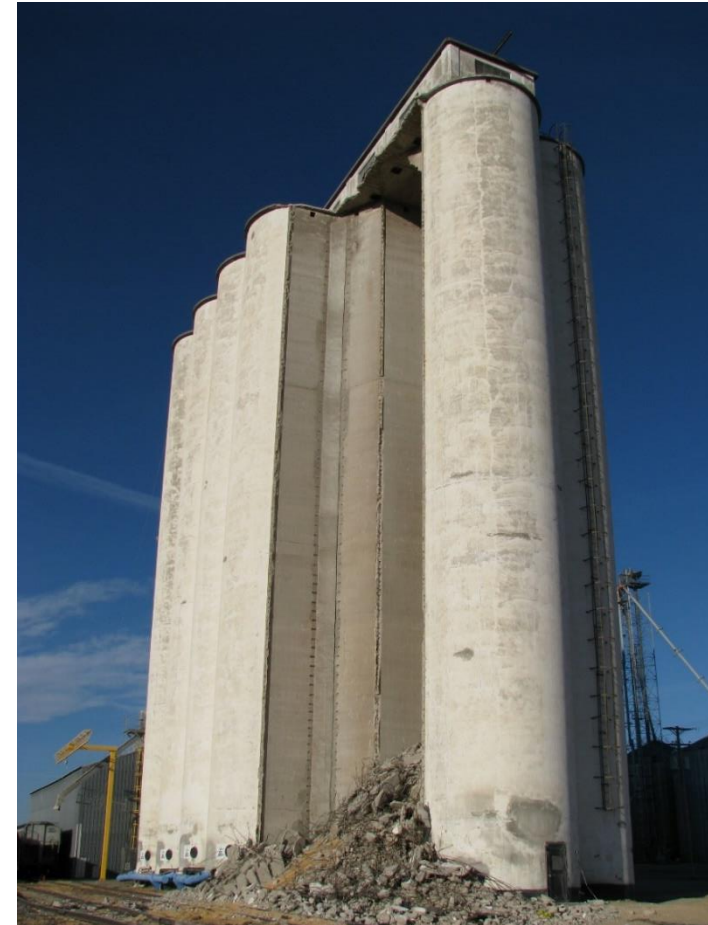
NOVEMBER 20, 2012 - SILO COLLAPSE OAKLEY, KS

CONSTRUCTED MID 1950'S

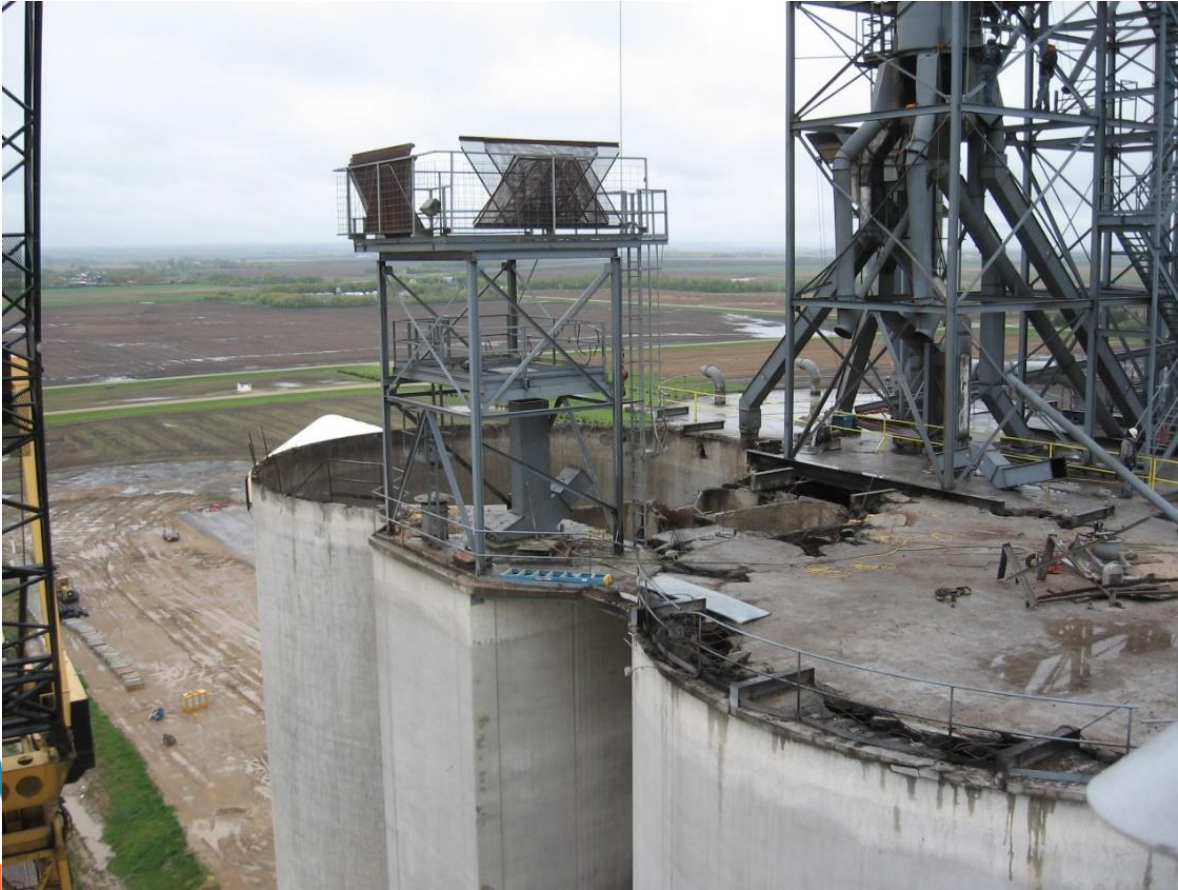
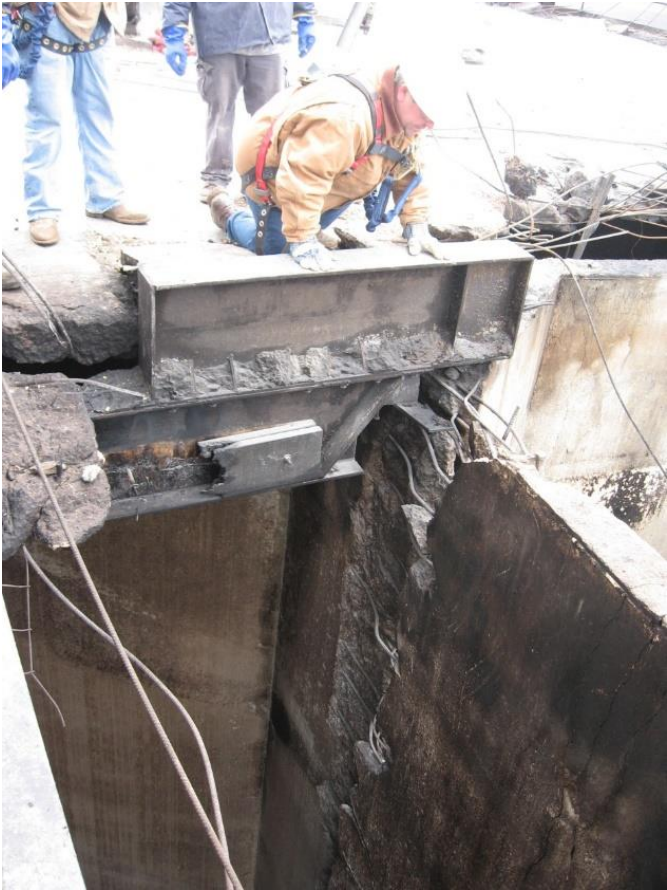
APRIL 13, 2010 GRAIN DUST EXPLOSION

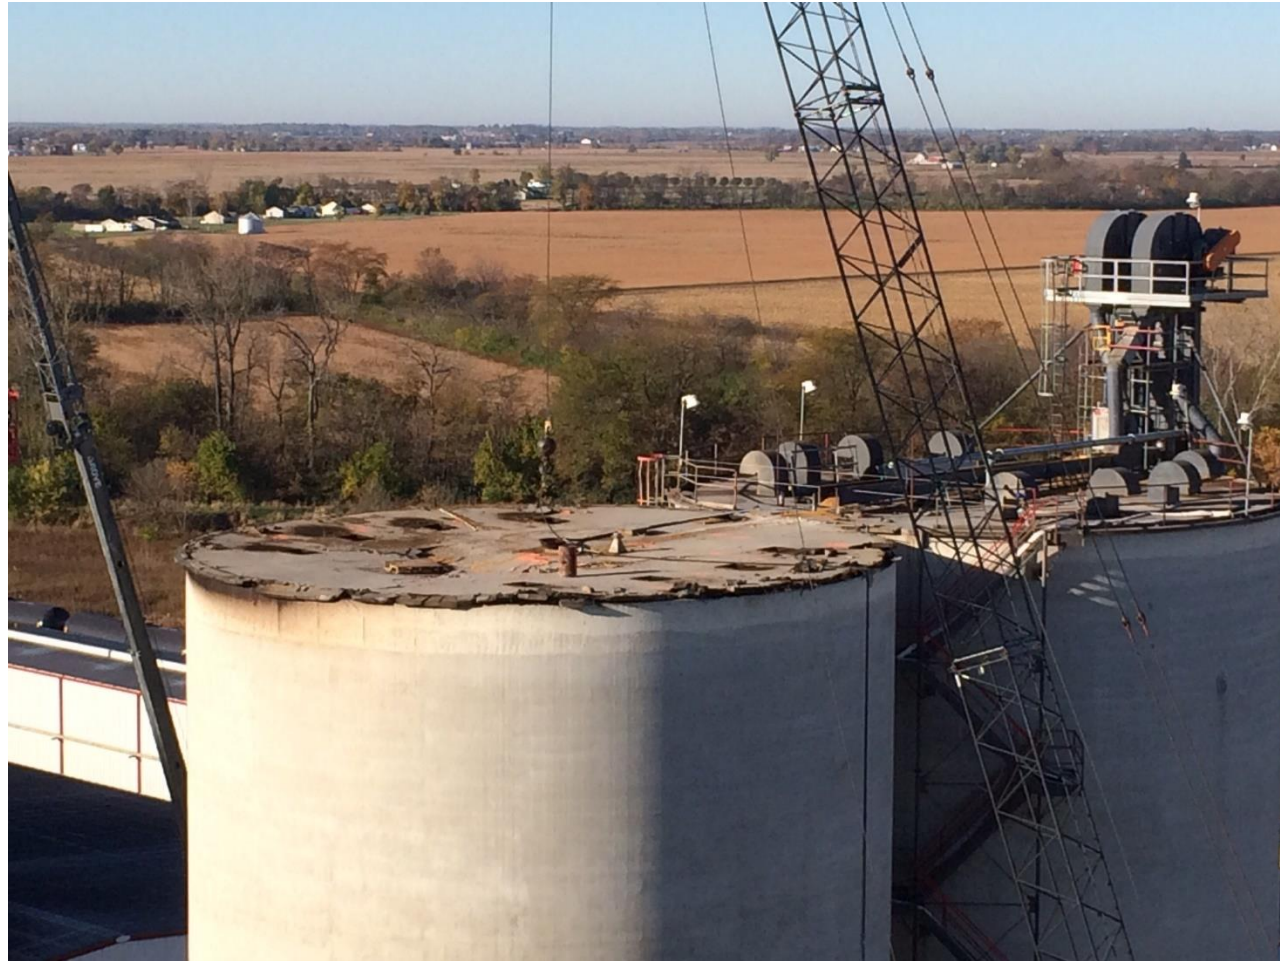
OHIO SILO EXPLOSION, OCT. 2014

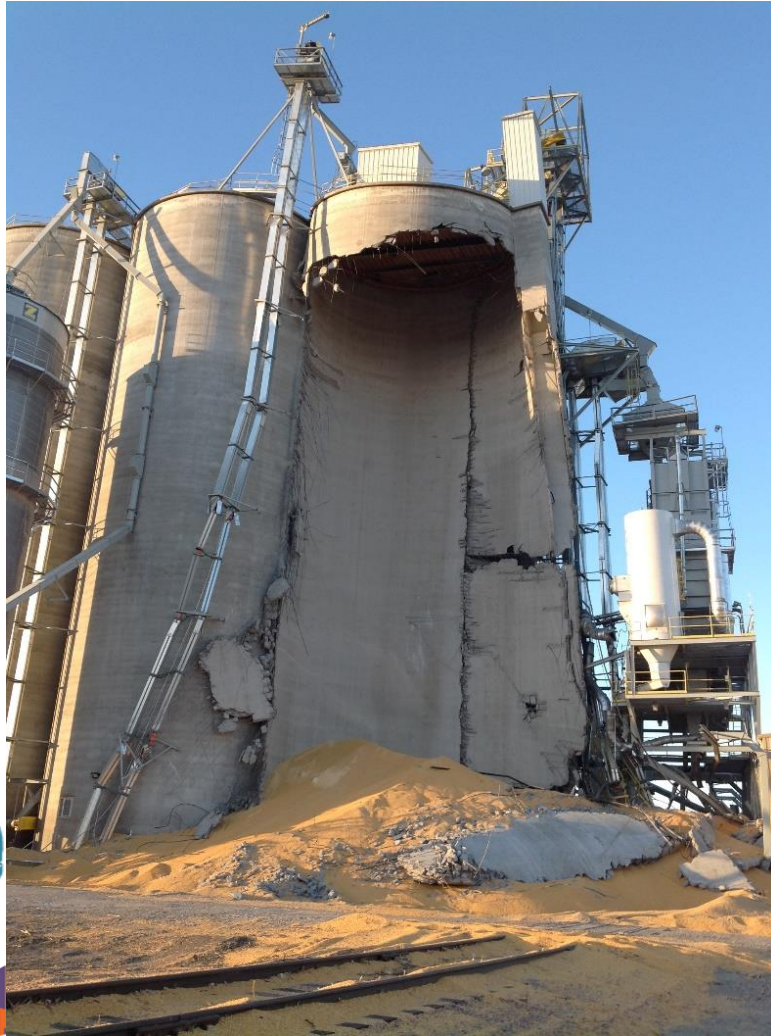
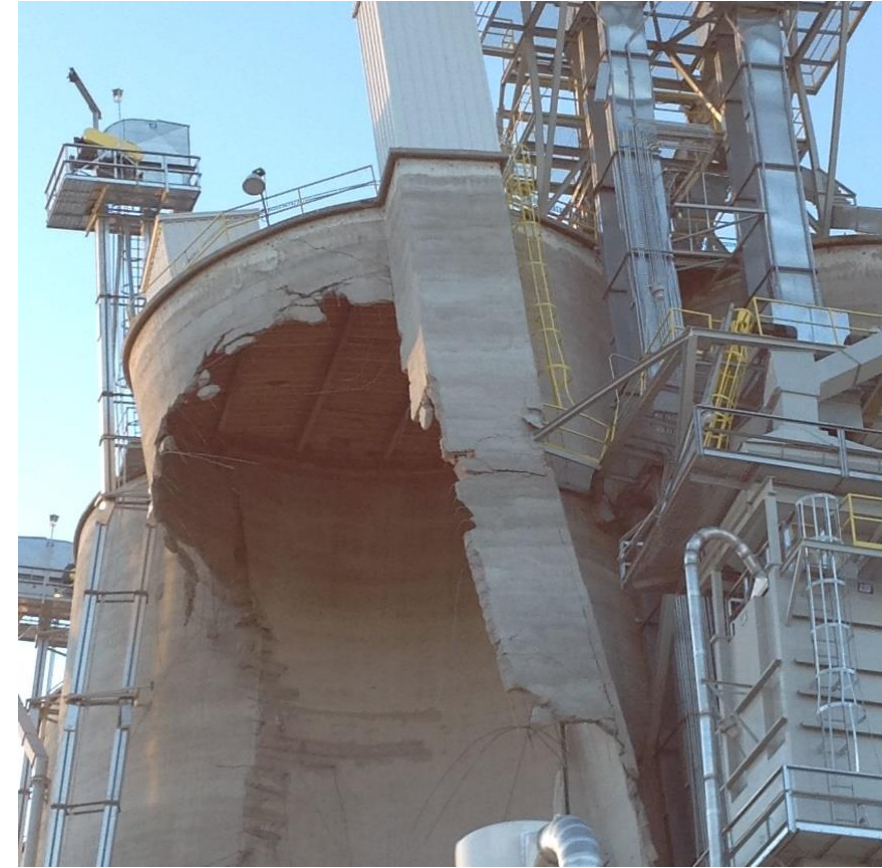
2014 CONCRETE SILO FAILURE

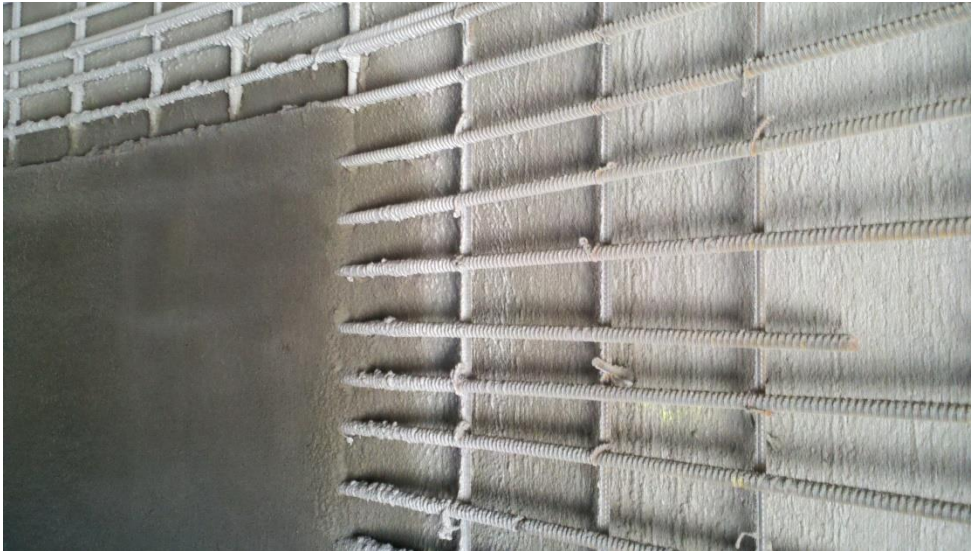
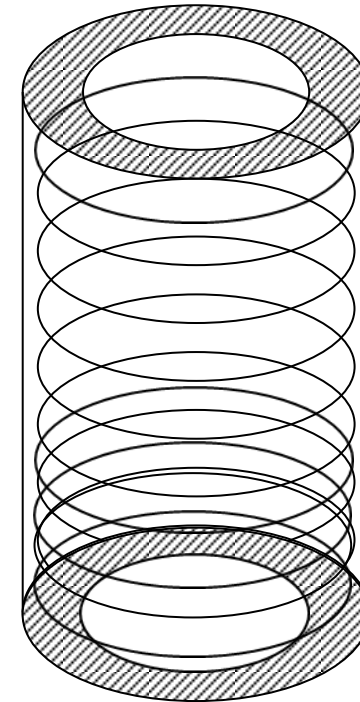
Gradient Pressure Theory

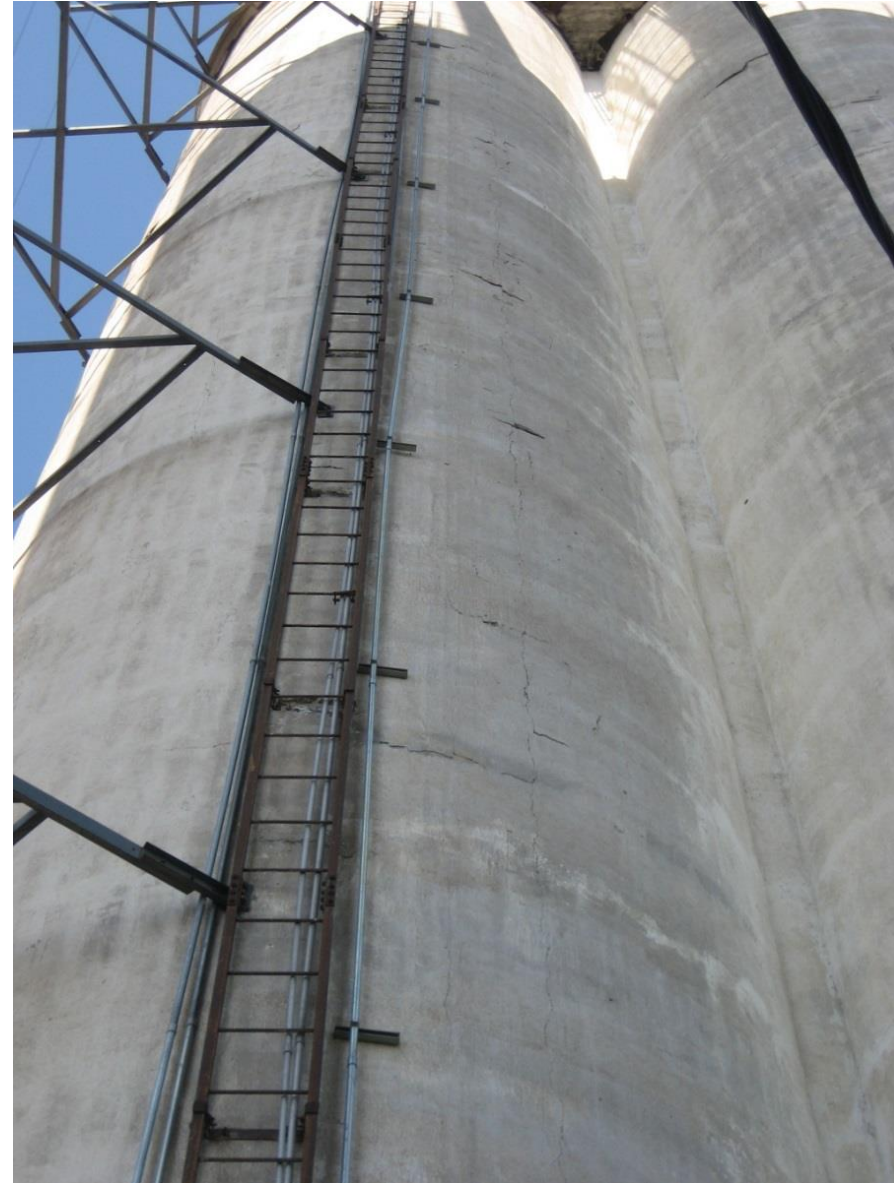
While Inspecting, look for cracking

Cracking is an indication of structural deficiencies of the concrete wall

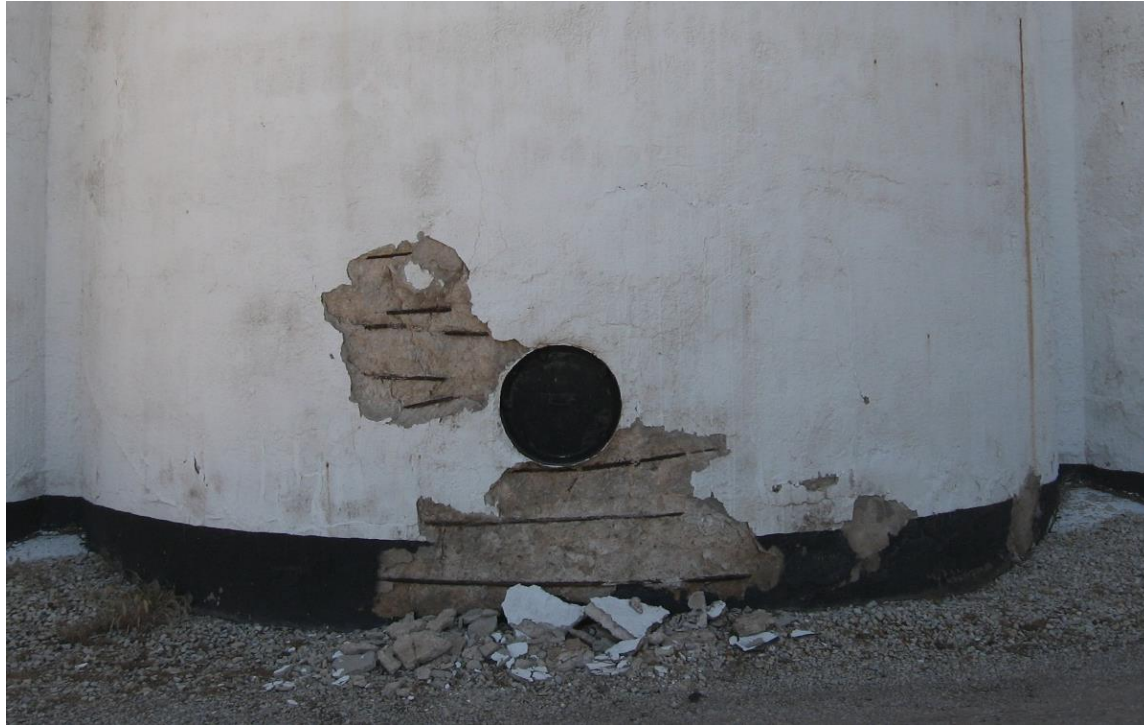
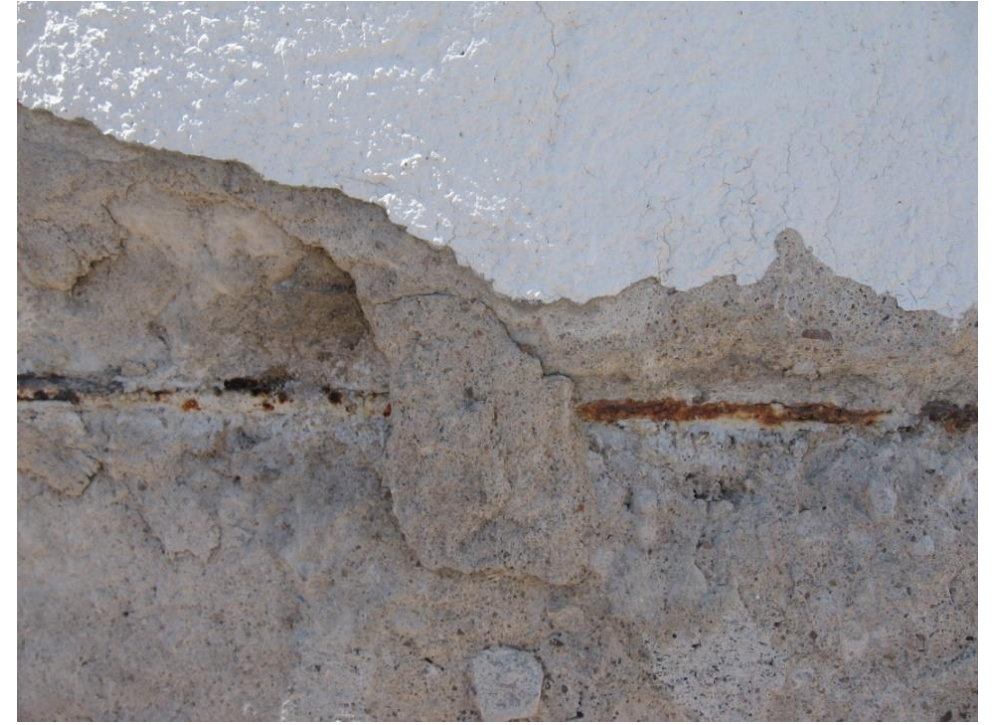
SPALLING CONCRETE EXPOSED REBAR, CONCERNED?

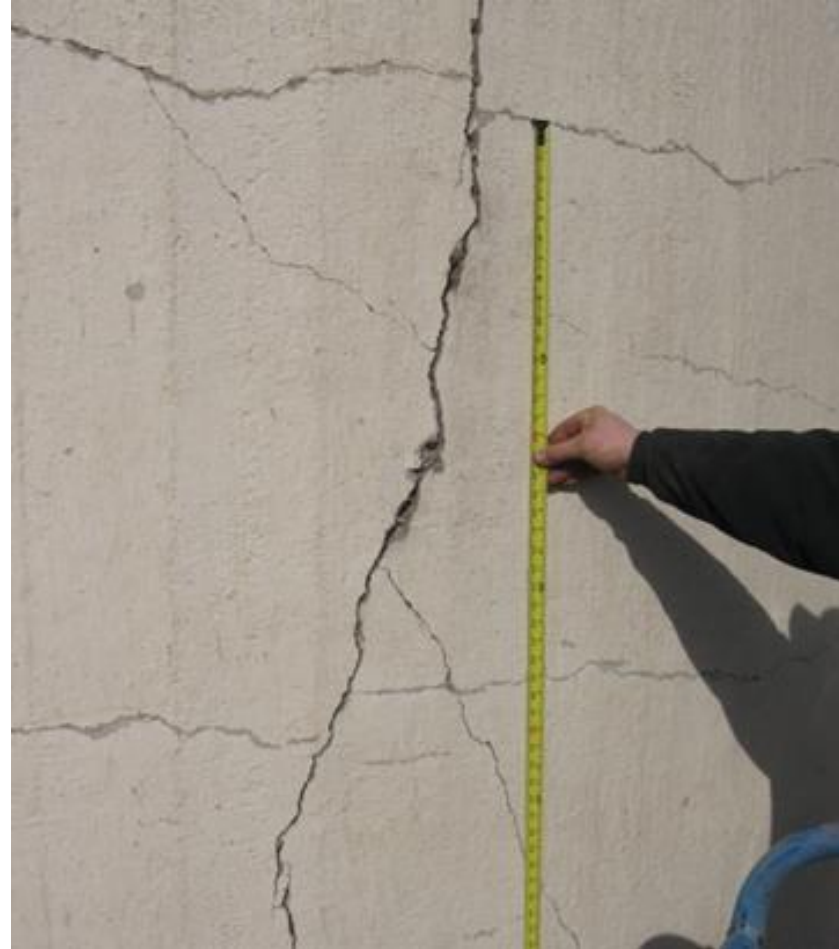
SPALLING AND DETERIORATION

WELL DEFINED CRACKS...

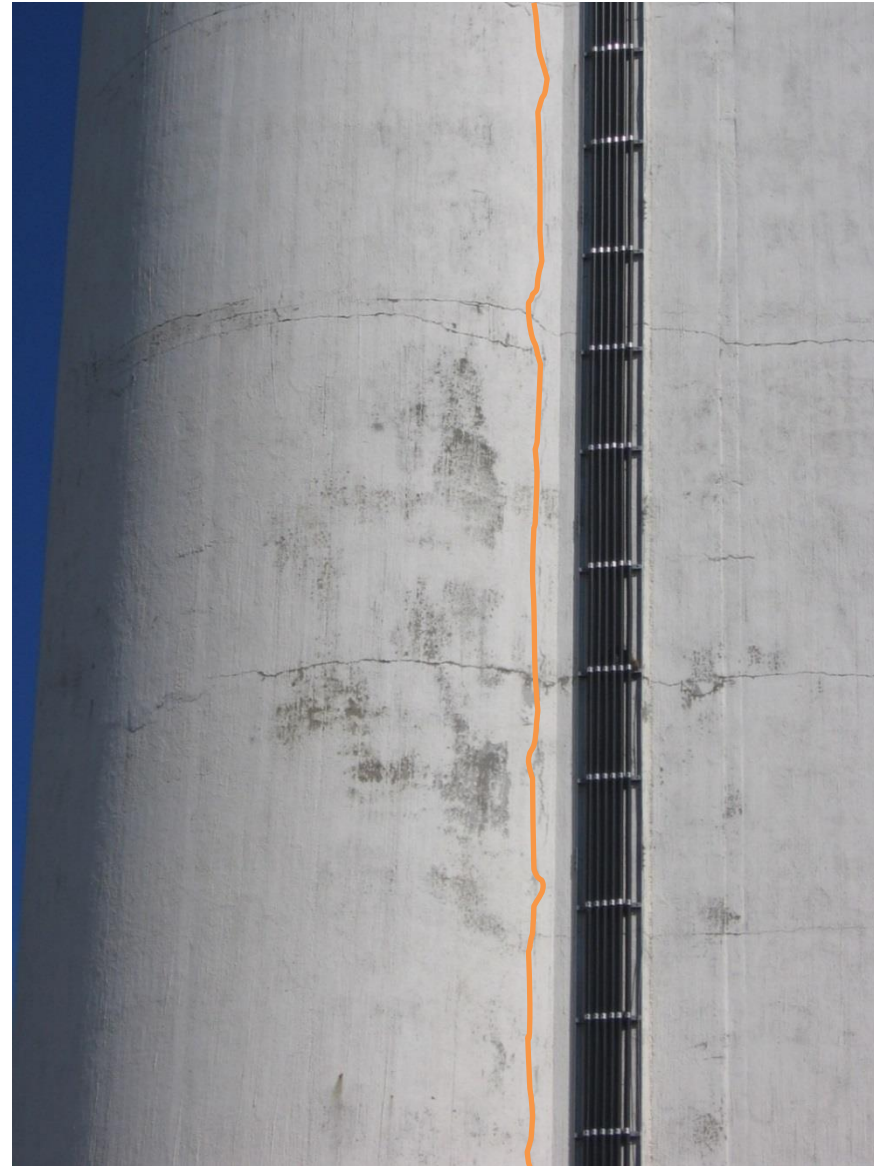
Define these Cracks.

“H” Cracks

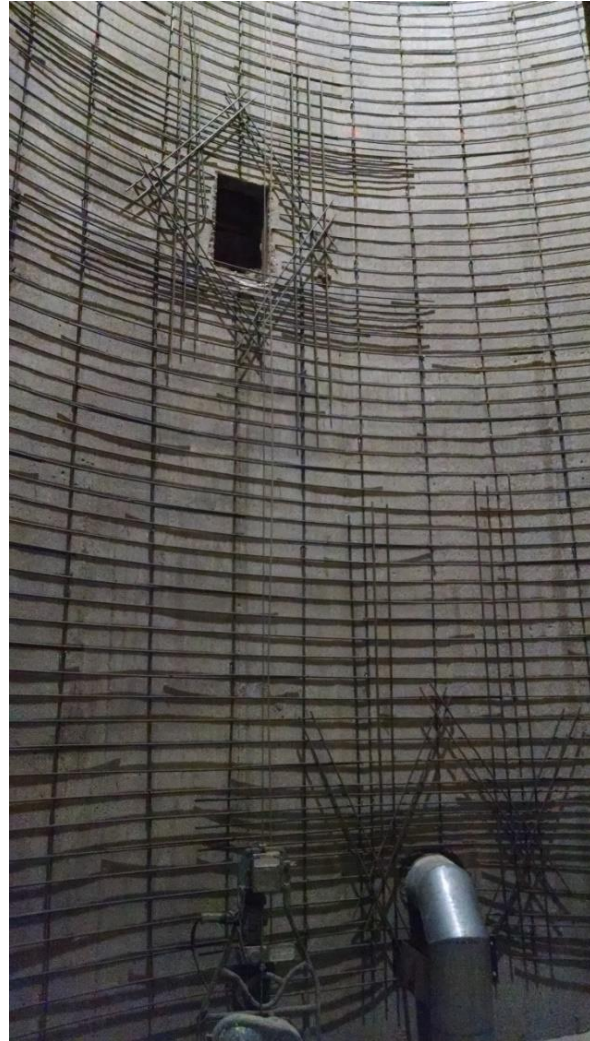
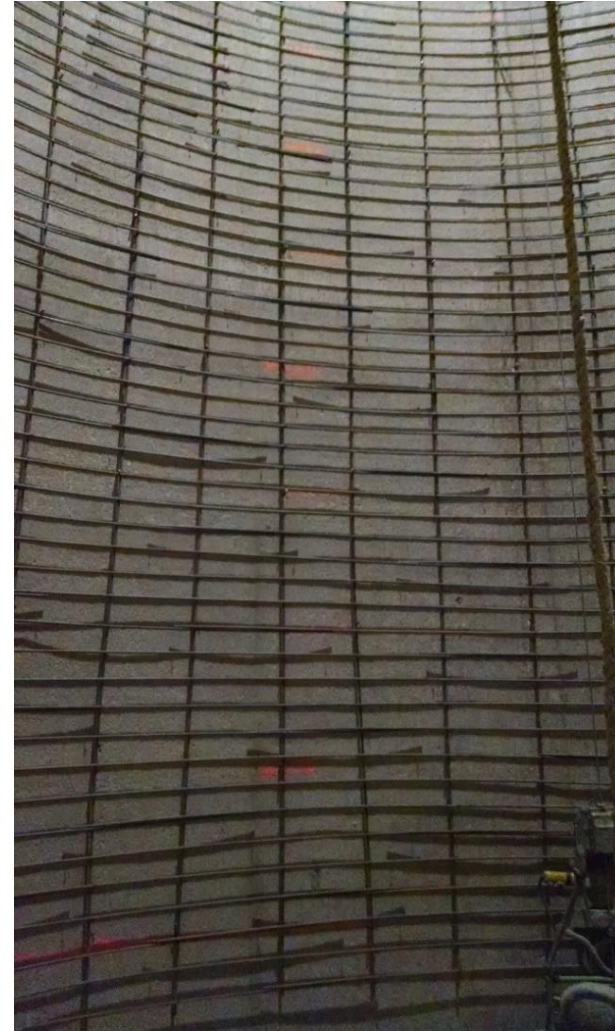
What can be done? Liner?

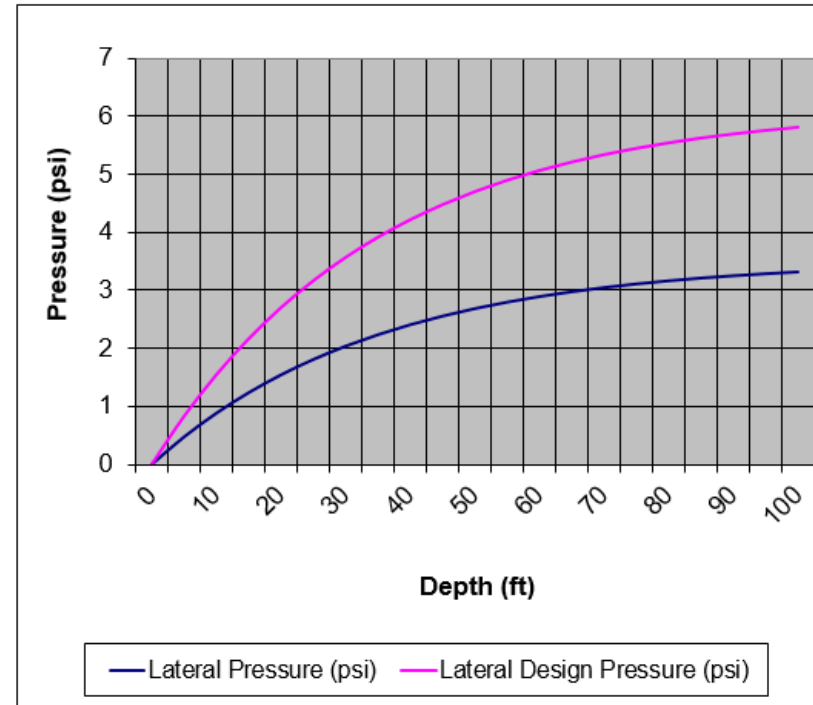
Grain Bin Load Calculator

24	ft	Diameter of bin	
110	ft	Height of bin	
4	in	Thickness of Liner	
3500	psi	Strength of Liner	
0.5	in	Size of Bar (Diameter)	
6	in	Vertical Spacing of Bars	
60000	psi	Yield Strength of Rebar	
1.5		Overpressure coefficient (1.35 - 2.00)	
0.58		Coefficient of friction	CHART
38	°	Emptying angle of repose	CHART
23	°	Filling angle of repose	CHART
49	lb/ft ³	Density of commodity	CHART

0.033	in ²	Area of steel per inch of height	
0.299		k; Ratio of internal lateral pressure to vertical pressure	
11.280	psi	Vertical pressure	
3.374	psi	Lateral Static pressure	
5.904	psi	Lateral Design Pressure	
25.980	ksi	Hoop Stress	
36.000	ksi	Allowable Stress in Rebar Provided	
		Hoop Stress Check	OK
0.080	As	Min. Area of Steel Check	OK
0.008	As/Ag	Temp. and Shrinkage Check	OK
